RUDDER CONTROL BINDING

AIN

February 5, 2012

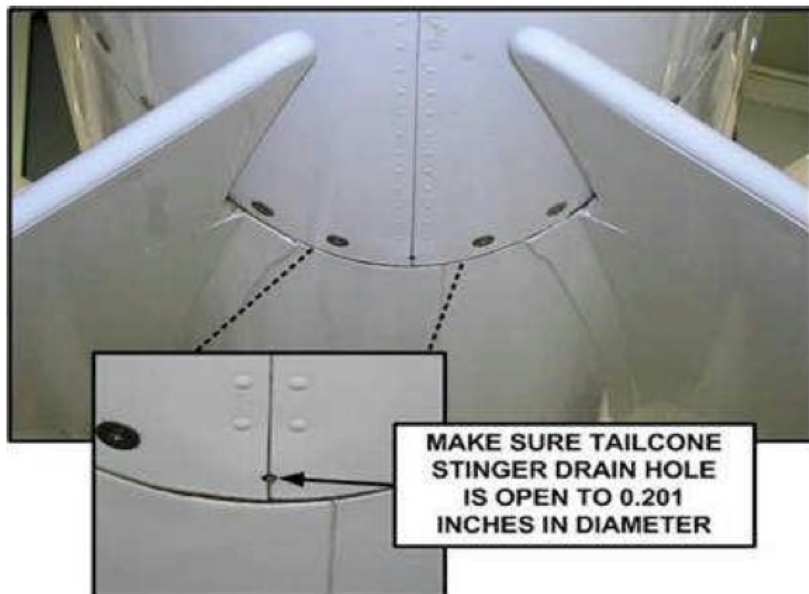
Team Excel is requesting all Model 560XL/XLS/XLS+ operators inspect the drain hole in the lower forward edge of the tailcone stinger for proper size. The hole must be 0.201 inches in diameter. The inspection should also verify the drain hole is open and free of debris.

A potential exists for water to accumulate in the tailcone stinger, leading to the possibility of the rudder control cable pulleys freezing at altitude or in cold weather conditions.

Cessna is currently developing further field modifications for the tailcone stinger drain hole, which will be communicated in early 2011. For the interim, operators should verify the rudder control system has freedom of movement. If the aircraft is exposed to ramp conditions in long periods of precipitation, operators should also verify the tailcone stinger drain hole is clear and draining.
